ELECTRICITY INDUSTRY PARTICIPATION CODE DISTRIBUTED UNMETERED LOAD AUDIT REPORT

JACKS POINT AND MERIDIAN ENERGY NZBN: 9429037696863

Prepared by: Rebecca Elliot

Date audit commenced: 4 March 2024

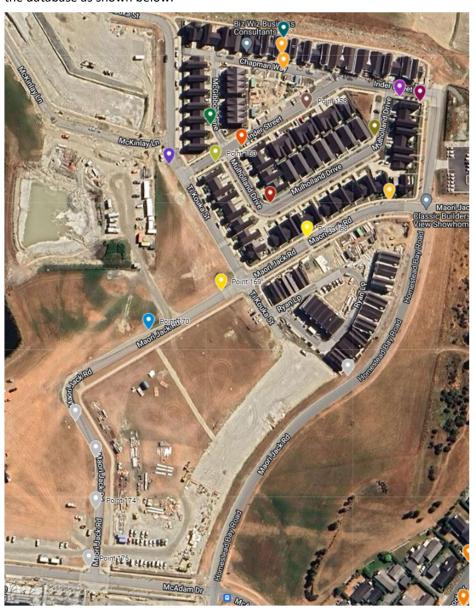
23 additional items of load were found in the field. 22 of these are located in a new development area in Jacks Point. These are likely to have been connected since March 2022 based on when the new ICPs on these roads started being electrically connected. The change management process is discussed in **section 3.1.**

The field audit identified a new area of development with 22 streetlights which have not been added to the database as shown below:

The Jacks Point subdivision has a lot of development in progress. I recommend above that the change management processes are reviewed as these additions are not being captured. As detailed in **section 2.5**, these are expected to have been electrically connected since March 2022 based on when the new ICPs on the network started being electrically connected.

received. I recommend that the field management processes including the connection of new streetlight circuits is reviewed to confirm that Delta is still the field contractor.

Recommendation	Description	Audited party comment	Remedial action
Database accuracy	I recommend that Meridian review the change management processes with all relevant parties.	Meridian has worked with Aurora and Delta to identify the gap in the New Connections process for Jacks Point. The outline of the process is in Participant Response.	Identified
