ELECTRICITY INDUSTRY PARTICIPATION CODE  
RECONCILIATION PARTICIPANT AUDIT REPORT

NOVA ENERGY LIMITED  
NZBN: 9429030450660

Date audit commenced: 13 May 2024

Date audit report completed: 17 June 2024

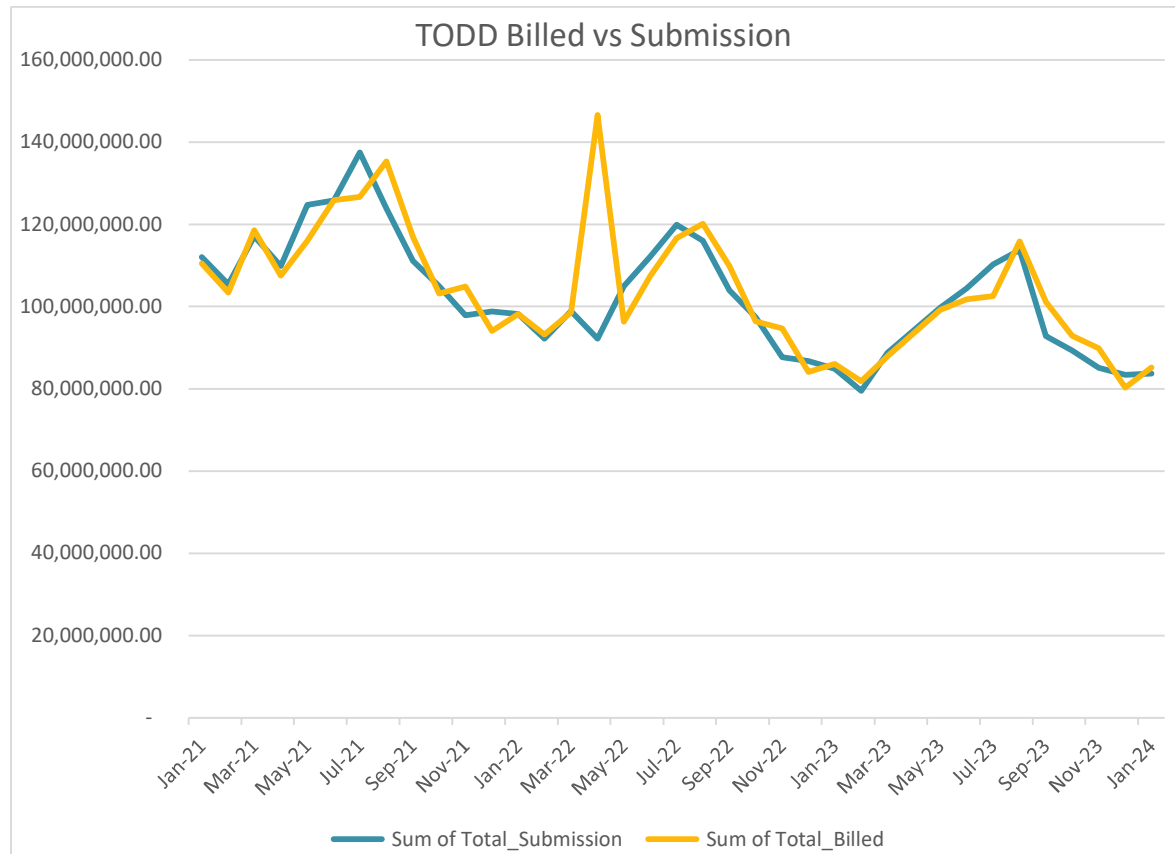
I checked the difference between submission and electricity supplied information for the period January 2021 to January 2024, and the results are shown in the chart below. The total difference is 0.7% for the year ending January 2024 (billed higher than submission).

The spike in the billed data for April 2022 was investigated during previous audits. The issue was caused by a billing error for an ICP connected to TUI1101 in April 2023. The following month the incorrect invoice was reversed. The reversal made the overall volume billed at TUI1101 negative for May 2022, so it was replaced with a zero so that the reconciliation manager portal would accept the file.

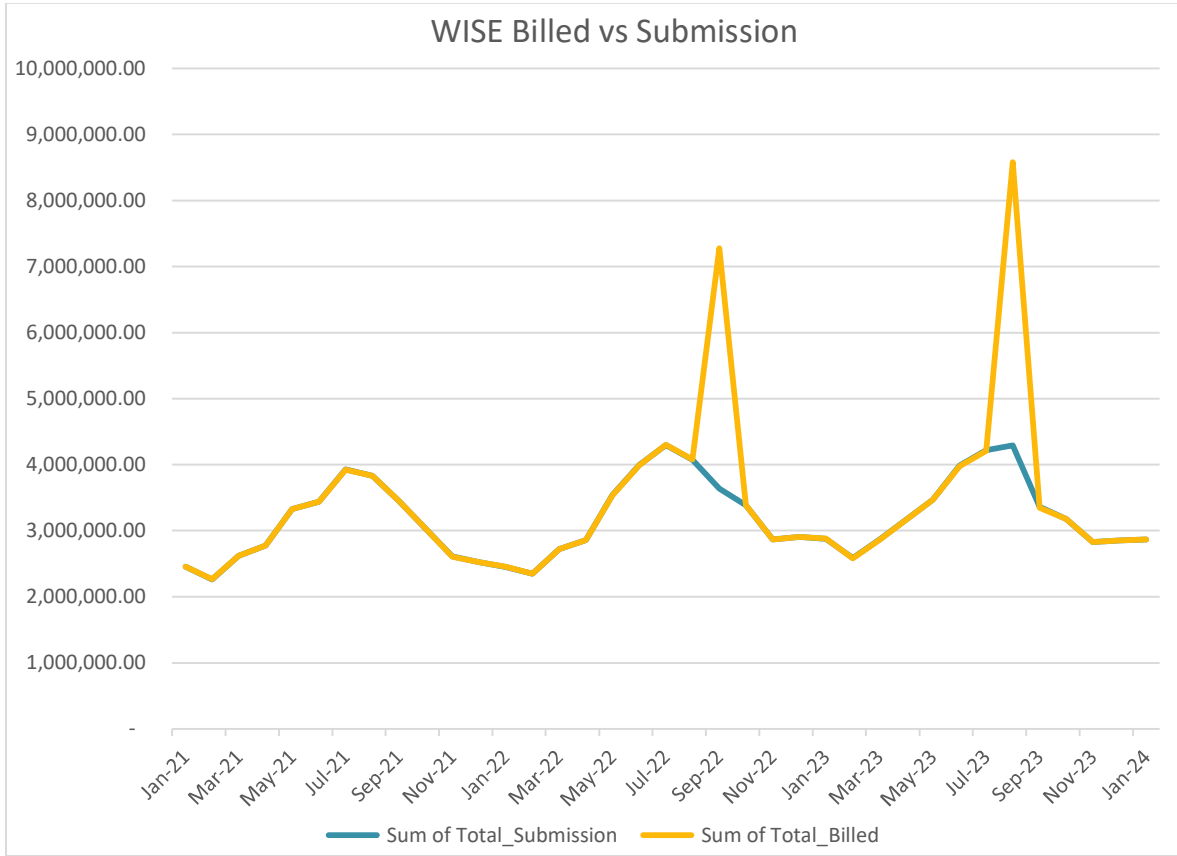
I checked the difference between submission and electricity supplied information for the period January 2021 to January 2024, and the results are shown in the chart below. The total difference is 10.4% for the year ending January 2024 (billed higher than submission). This was due to double counting of billed information in September 2022 and August 2023. The “as billed” files were regenerated just prior to submission which added the data originally generated and the new data set together. Following discovery of this error, the process has been adjusted to ensure that the billed data is not double counted.

If August 2023 is excluded, the difference between billed and submitted data for the year ending January 2024 is 0.1%.

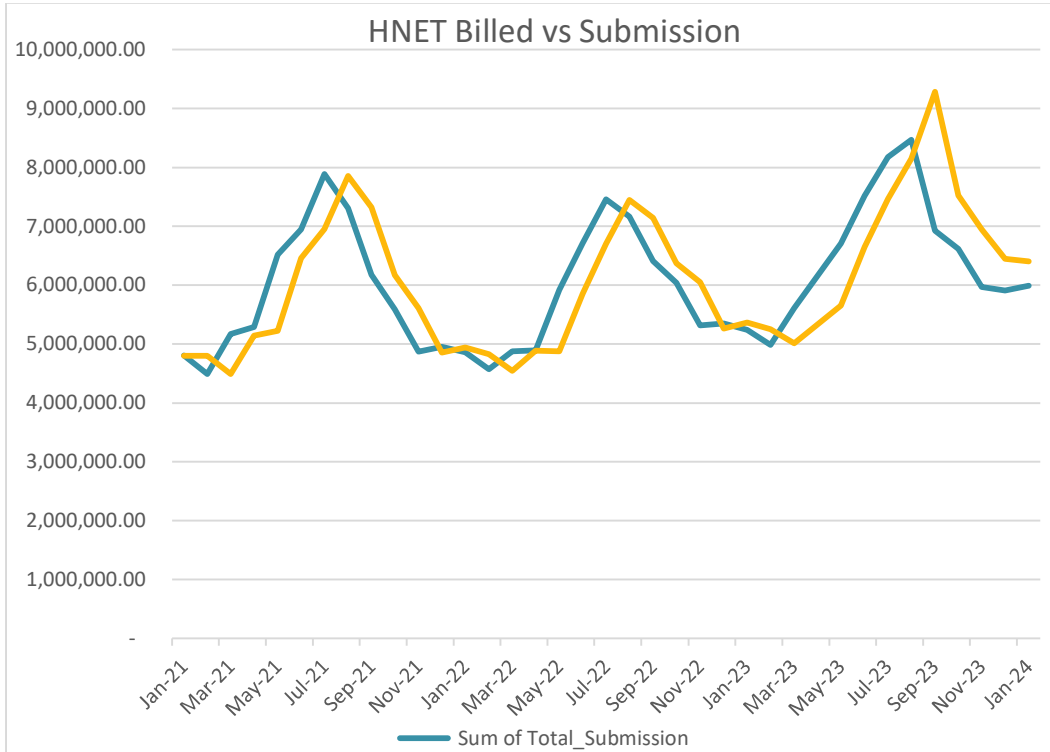
I checked the difference between submission and electricity supplied information for the period January 2021 to January 2024, and the results are shown in the chart below. The total difference is 2.6% for the year ending January 2024 (billed higher than submission).

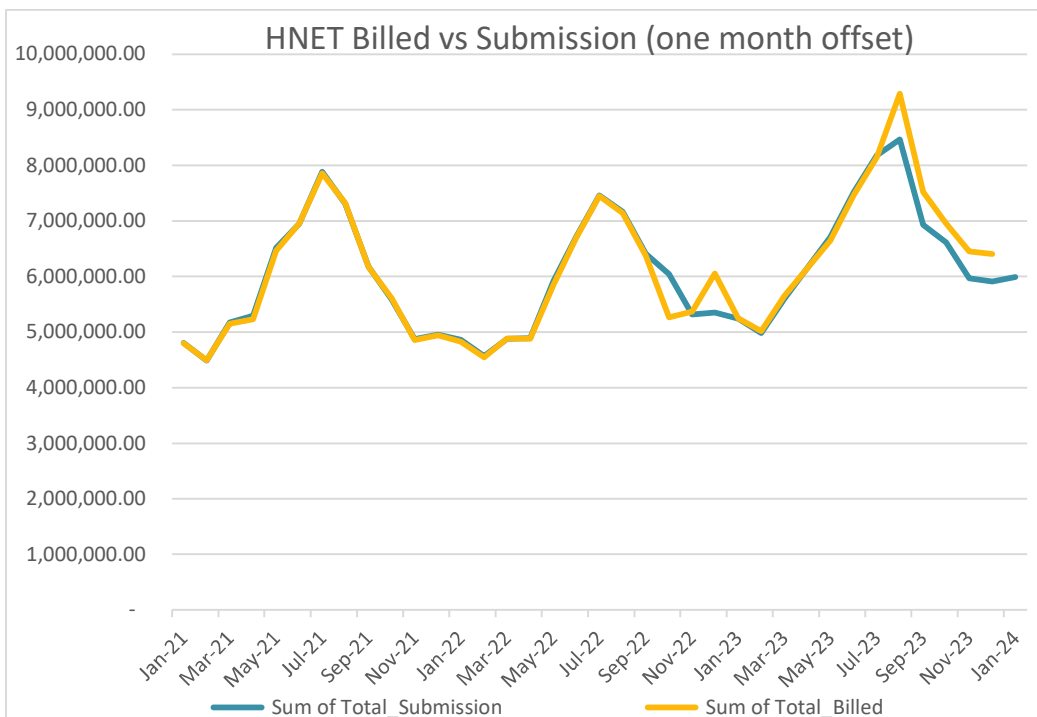
When the data is adjusted for the one month offset between billed and submission data the larger difference between the billed and submitted data from August 2023 onwards is visible. It relates to HHR ICP 0326516743LC9D7, which due to an error had the HHR submission flag set to no on the registry. TODD did not produce HHR volumes, but it was included in the billed submissions. The ICP's submission flag has been corrected and revised submission information will be washed up. Compliance is recorded in this section because the billed data submission was correct.
