Northland tower collapse 20 June 2024

Report on the review conducted
by the Electricity Authority
Te Mana Hiko under section 18 of
the Electricity Industry Act 2010

13 September 2024

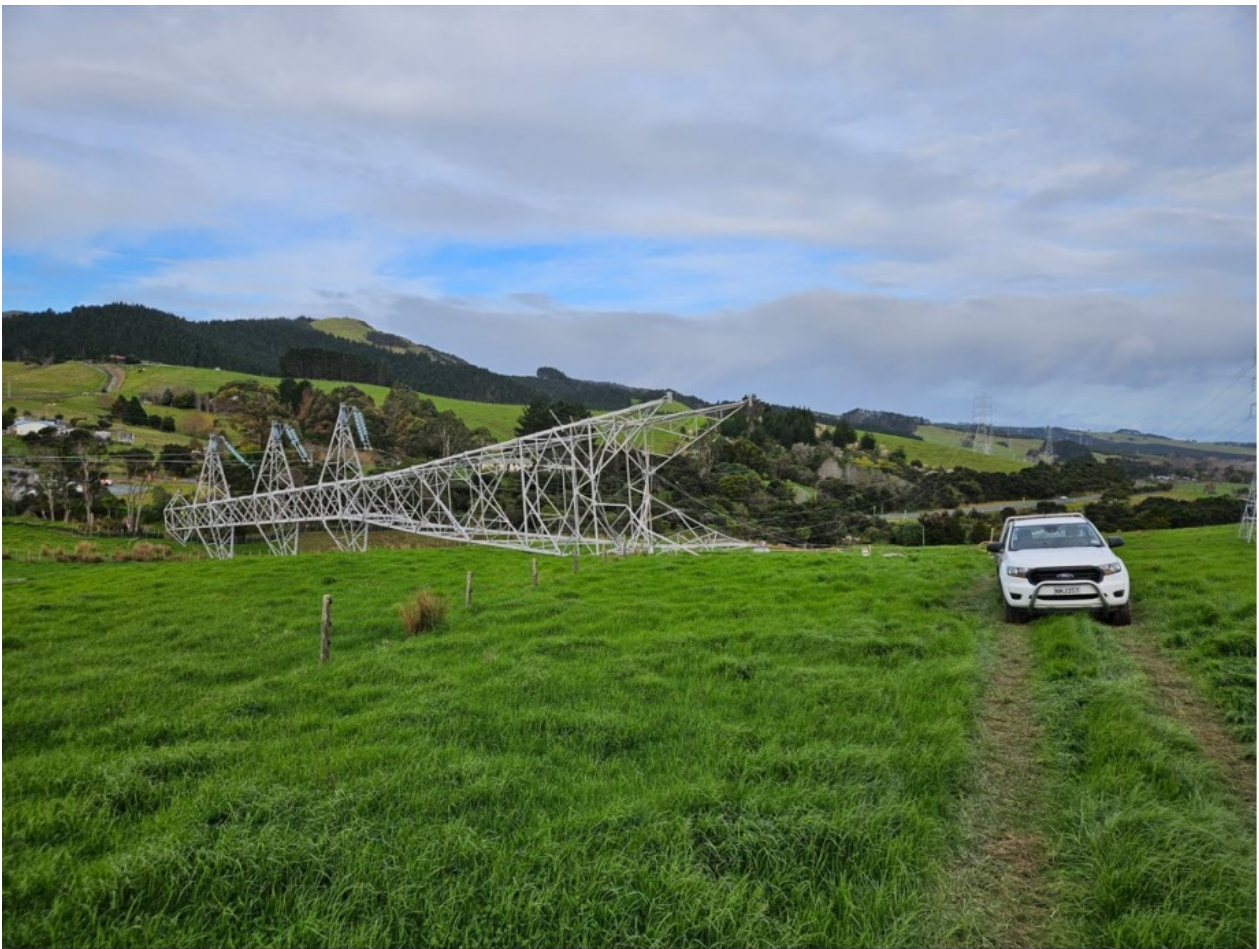
Figure 5: Collapsed tower 130 near Glorit

- 7.4. The collapse of a 220 kV transmission tower on the Henderson – Marsden A line near the rural community of Glorit (HEN-MDN-A130 or tower 130), was the direct cause of the event (Figure 5).

- 7.5. The collapse of tower 130 grounded the in-service circuit Huapai – Marsden circuit 1. Detecting a blue phase to earth fault, protection operations at Huapai and Marsden quickly and correctly tripped the circuit.³⁹
- 7.6. The fact that one of the two 220 kV circuits (Bream Bay - Huapai circuit 1) was removed from service at the time of the tower collapse, and that Northland was on N security as a result, did not contribute to the cause of the event in any way. Should any tower on the Henderson – Marsden A line collapse at any time, regardless of asset outages and the prevailing security level, Northland would suffer a region-wide blackout.

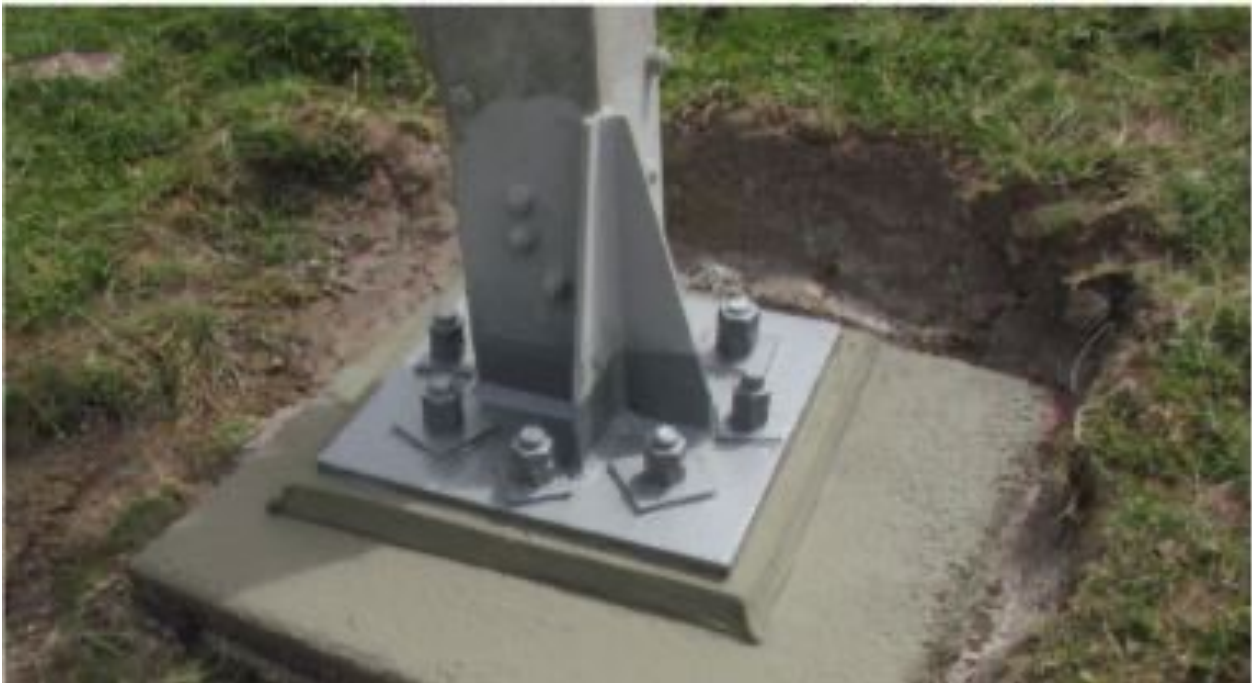
Figure 6: Refurbished tower foundation

7.14. A refurbished foundation is shown in Figure 6.

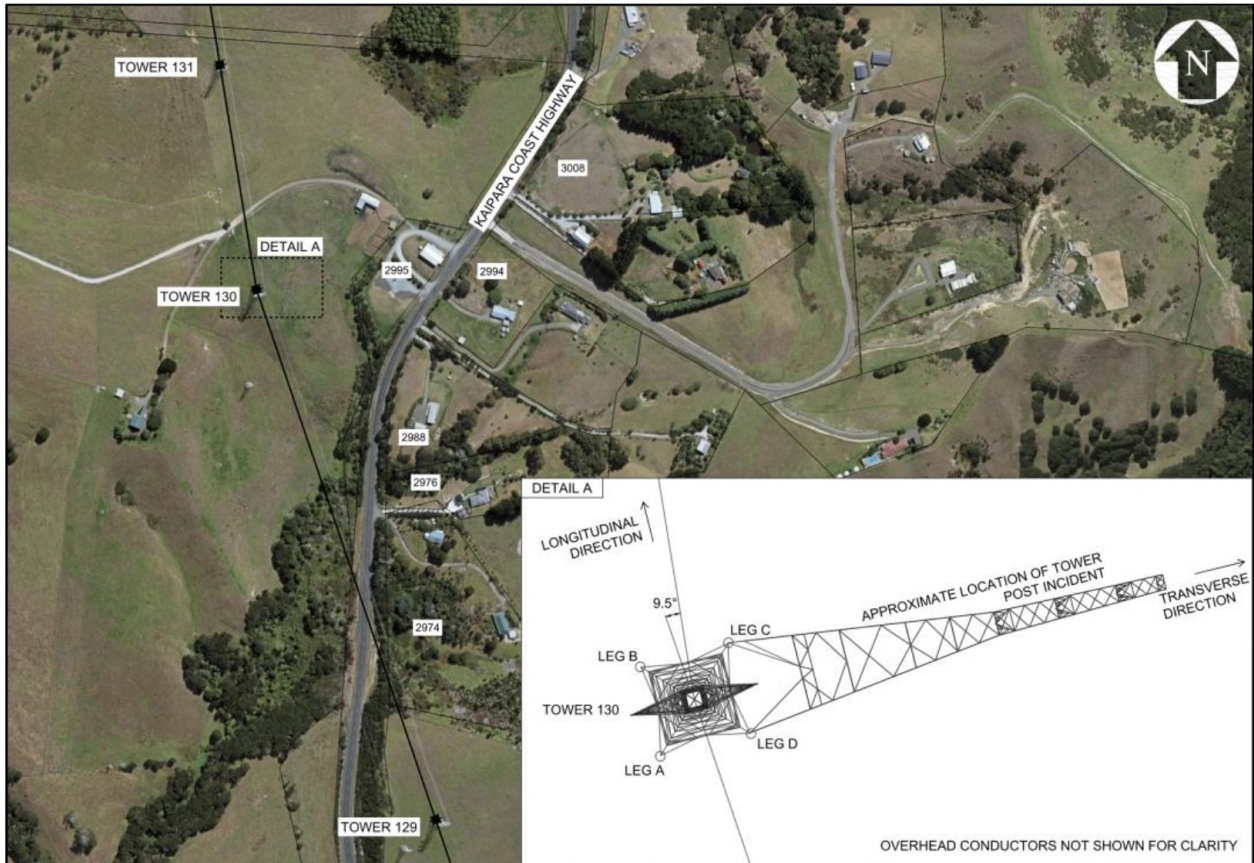
Figure 7: Tower 130 location, leg references and longitudinal direction change

7.26. Shortly afterwards, possibly due to a drop in wind, the tower fell towards the east. When the tower started to fall, the team leader moved from their position at Leg D and ran away from the direction that the tower was falling. It is not clear precisely where TA1 and TA2 were in relation to the tower when it fell.⁴³ Fortunately, no one was physically injured when the tower fell.

- 7.27. Figure 7 shows that tower 130 is an angle suspension tower with conductors that form a 9.5-degree direction change between the two adjacent towers. This creates an obtuse angle in the line, carrying an 'interior angle' circuit (Huapai - Marsden circuit 1) on one side and an 'exterior angle' circuit (Bream Bay - Huapai circuit 1) on the other.

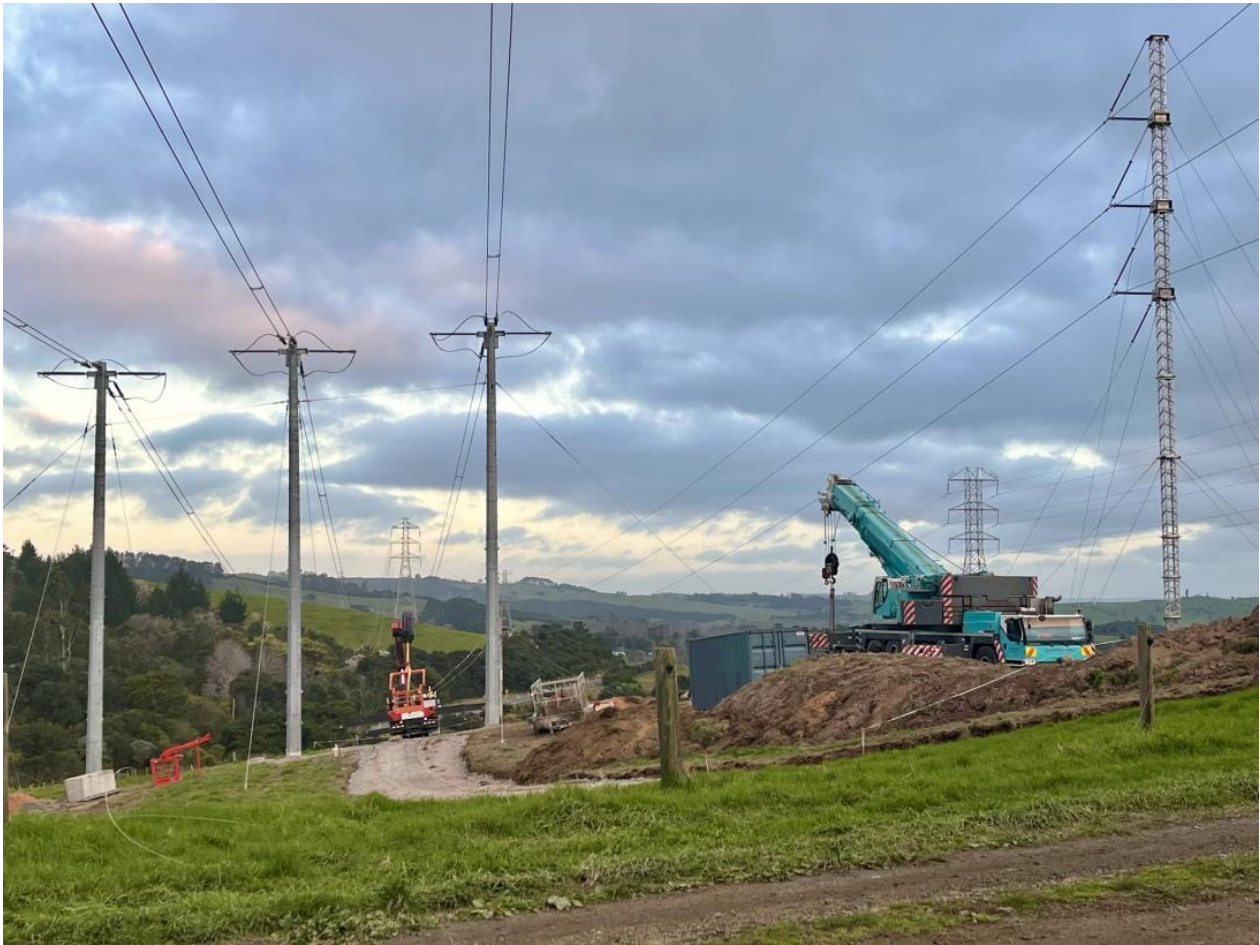
Figure 9. Temporary 220 kV circuit structures

- 9.37. Of the two North Island Lindsey towers remaining available after the tower 130 incident, one is currently located in Auckland, and one at Bunnythorpe, near Palmerston North.
- 9.38. This approach—storing the towers in containers and dispersing them geographically—was adopted following lessons learned from an earlier incident at Ruakura. For the Northland event, the Lindsey tower arrived on-site even before site access was fully established.
