ELECTRICITY INDUSTRY PARTICIPATION CODE  
DISTRIBUTED UNMETERED LOAD AUDIT REPORT

SOUTH WAIRARAPA DISTRICT COUNCIL  
AND MERCURY ENERGY LIMITED

Prepared by: Tara Gannon

Date audit commenced: 20 August 2024

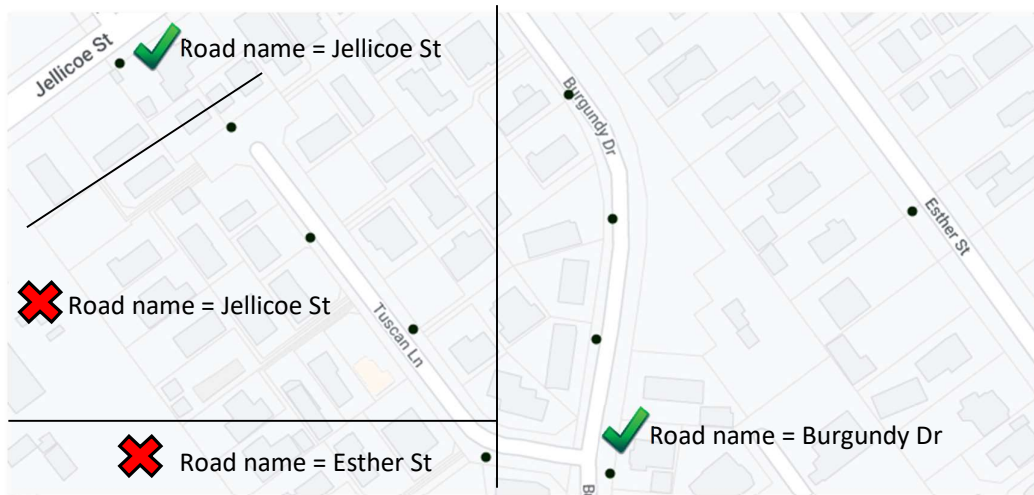
- 33 items of load had transposed GPS coordinates, with the northing value recorded in the easting field and vice versa. I confirmed that these issues have been resolved with the implementation of AMDS and all items of load have locations within the SWDC region.
- Some items of load had correct positions recorded but incorrect GPS coordinates. I checked previous exceptions and found they had been resolved, except for some lights on Tuscan Lane which are currently recorded with road names of Jellicoe St or Esther St.

I have repeated the recommendation to check and update the street addresses for items of load on Tuscan Lane.

Recommendation	Description	Audited party comment	Remedial action
Database address accuracy	Check and update the street addresses for lights recorded on Tuscan Lane, Martinborough.	South Wairarapa DC have advised that they plan to check and update these.	Identified
