ELECTRICITY INDUSTRY PARTICIPATION CODE  
DISTRIBUTOR AUDIT REPORT

POWERCO LIMITED  
NZBN: 9429037332174

Prepared by: Tara Gannon

Date audit commenced: 22 August 2024

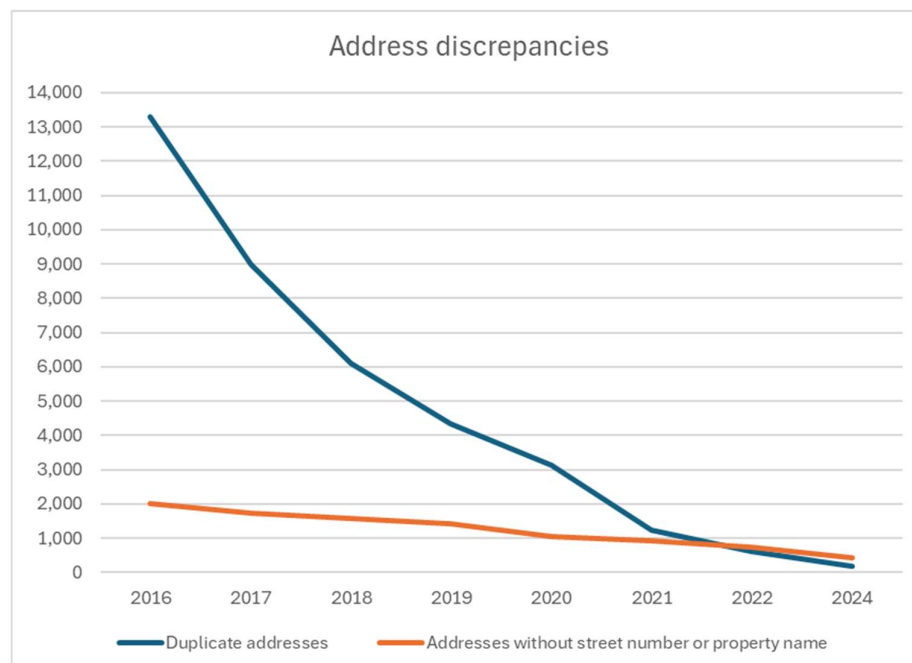
Some data discrepancies which require further investigation to resolve are not always corrected as soon as practicable, such as incomplete and duplicate addresses. Powerco has made significant process in resolving addressing issues over recent years. 565 ICPs in total have duplicate and/or incomplete addresses a reduction from 1,279 in total during the last audit. Some ICPs are affected by both issues.

Address issue	2024	2022	2021	2020	2019	2018	2017	2016	Difference this year
Duplicate addresses	190	629	1,238	3,132	4,348	6,091	8,973	13,302	-439
Addresses without street number or property name	442	727	925	1,062	1,423	1,584	1,733	2,013	-285

Powerco has continued to work through the exceptions, including reviewing fault and contractor site visit information to find more addressing details. I checked a sample of 32 of the exceptions that were still remaining and found:

- 18 had several dwellings close together with no street numbers,
- seven were on Rangiwai Island, which has no official street numbers, and
- seven were recently updated to unique complete addresses.

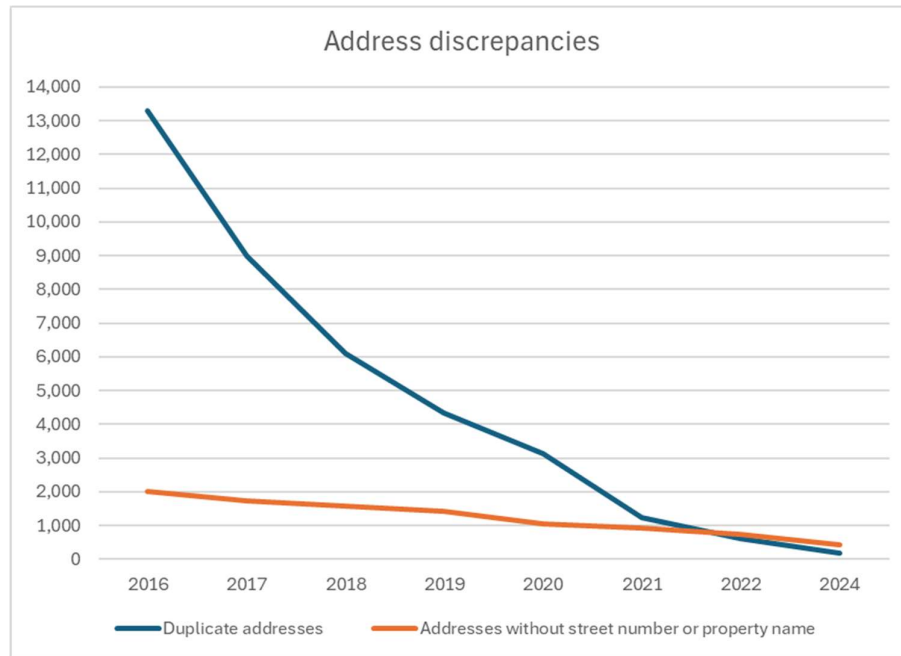
Address issue	2024	2022	2021	2020	2019	2018	2017	2016	Difference this year
Duplicate addresses	190	629	1,238	3,132	4,348	6,091	8,973	13,302	-439

Address issue	2024	2022	2021	2020	2019	2018	2017	2016	Difference this year
Addresses without street number or property name	442	727	925	1,062	1,423	1,584	1,733	2,013	-285

Powerco has continued to work through the exceptions, including reviewing fault and contractor site visit information to find more addressing details. I checked a sample of 32 of the exceptions that were still remaining and found:

- 18 had several dwellings close together with no street numbers,
- seven were on Rangiwa Island, which has no official street numbers, and
- seven were recently updated to unique complete addresses.

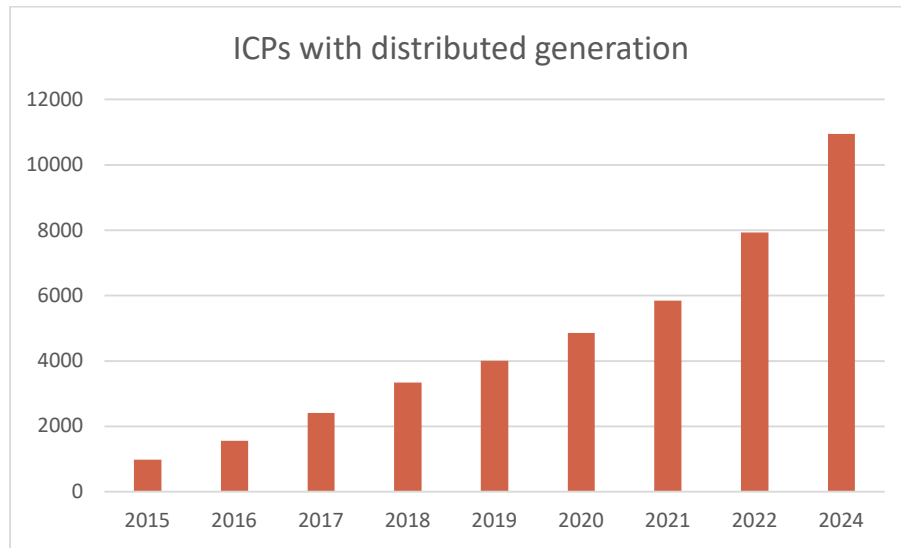
The list file recorded 10,944 “active” ICPs with a non-zero generation capacity. The table below tracks the number of ICPs with distributed generation by audit period end:

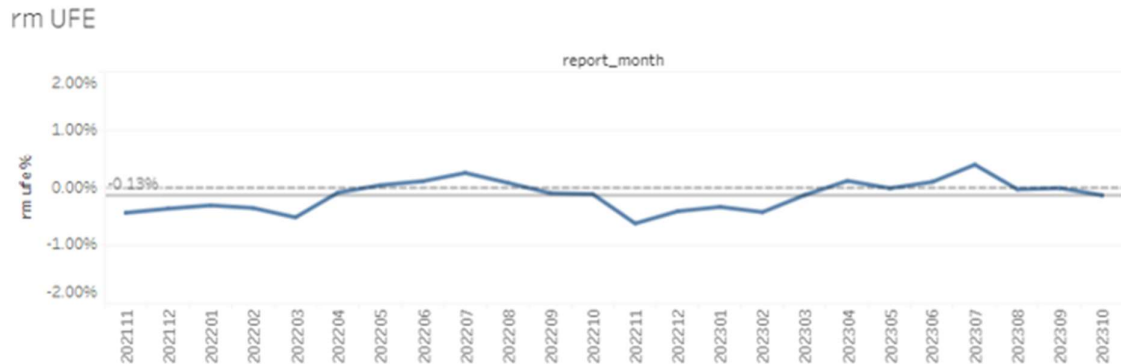
The review showed that once data for KIN0112POCOG was excluded, loss factors were within the  $\pm 1\%$  threshold indicated in the guideline by the Authority.

I compared this to the EMI UFE data for a sample of months and confirmed that the only differences between Powerco’s data and the EMI data were the volumes for KIN0112POCOG. Due to the way in which this NSP which has one consumer is reconciled, 100% of volume at the NSP is classified as UFE which distorts Powerco’s UFE totals in the EMI report, making it appear as though Powerco’s UFE across all balancing areas is outside the threshold. The EMI UFE information showed that the 12-month rolling UFE ratio is +1.861% for the year ending June 2024 and has varied between a +1.861 and +2.074% rolling 12-month UFE ratio over the past year. It is reasonable to exclude this NSP because it is not genuine UFE.

Powerco’s review concluded that the loss factors were in general slightly too high. The review proposed some loss factor changes but recommended that the changes were held until the 2025 financial year to minimise the impact. Investigation found the largest UFE differences were in the Valley

balancing areas and were caused by fluctuations in usage for large customers, and back feeding processes causing spikes and corresponding dips within the different Valley balancing areas. Powerco intends to address these issues by combining some balancing areas to better reflect how they are fed and adding some new individual loss factors over the coming years.
