Northland tower collapse 20 June 2024

Report on the review conducted
by the Electricity Authority
Te Mana Hiko under section 18 of
the Electricity Industry Act 2010

13 September 2024

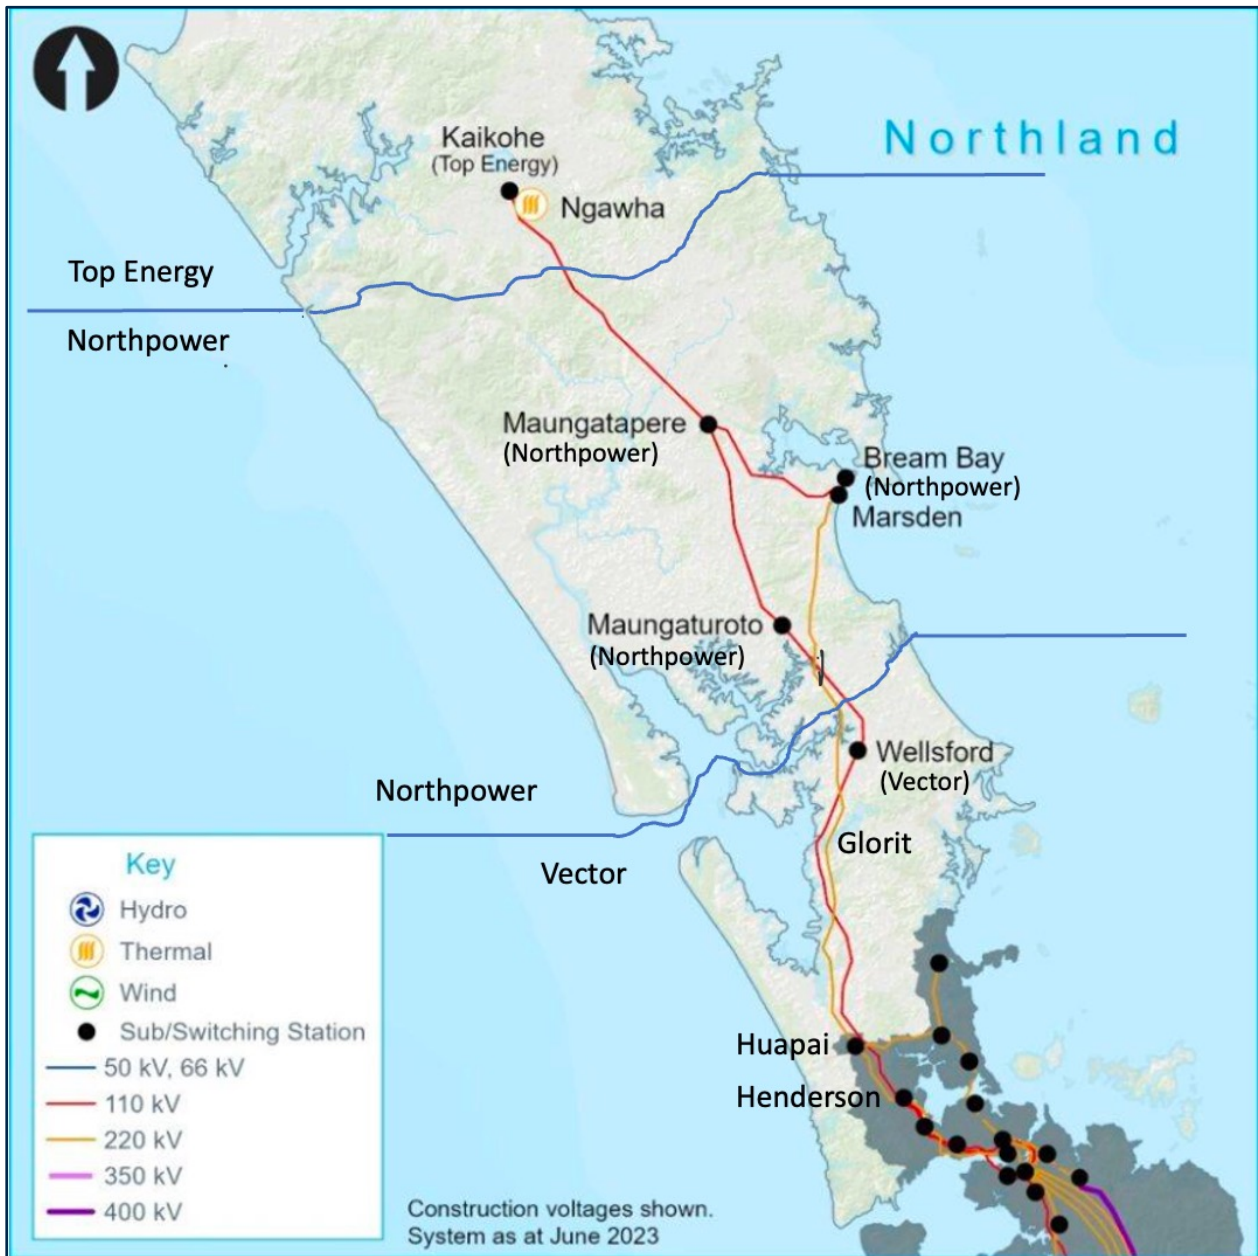
Figure 1. Northland transmission lines and distributor boundaries

3.1. Figure 1 shows that the Northland region is a long peninsula, with electricity supplied by a 220 kV double-circuit line from Huapai (orange) and a 110 kV double-circuit line from Henderson (red). The circuits carried on these lines are normally operated in parallel. The two Northland line routes run in parallel for part of their length. The double-circuit 110 kV line dates from the 1930s and has a much lower circuit capacity than the two circuits on the 1960s-1970s era 220 kV line.

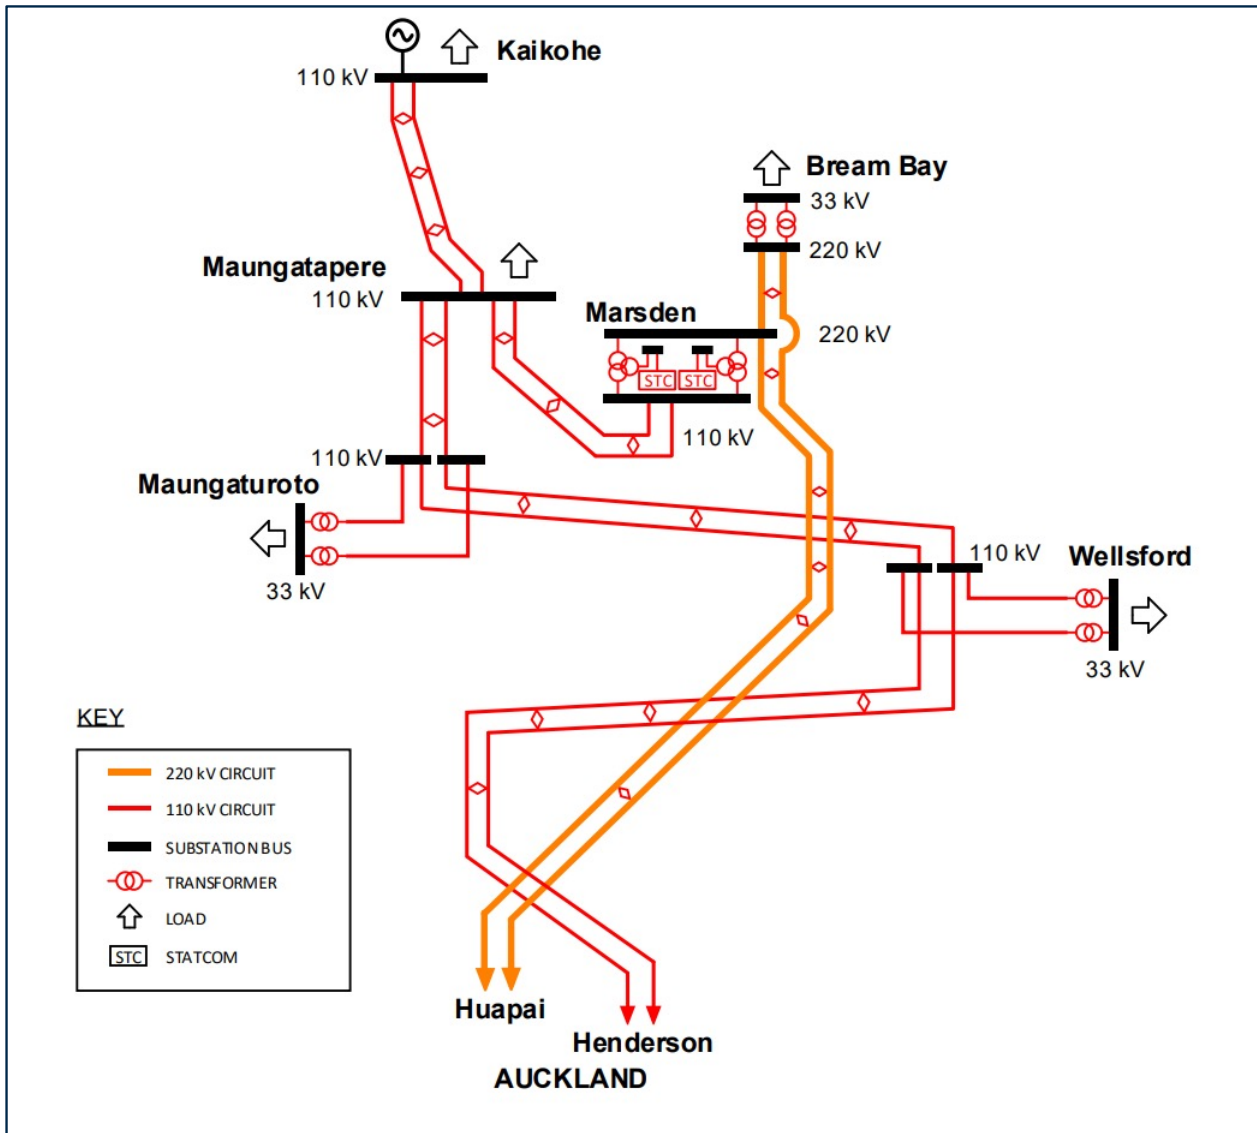
Figure 2. The Northland grid normally provides N-1 security

- 3.5. Figure 2 shows the two double circuit lines that supply Northland from Huapai (220 kV) and Henderson (110 kV). If either of the 220 kV circuits (either Bream Bay - Huapai circuit 1 or Huapai - Marsden circuit 1) are removed from service, or develop a permanent fault and trip, the normal N-1 security level for Northland reduces to N security until the circuit is returned to service.

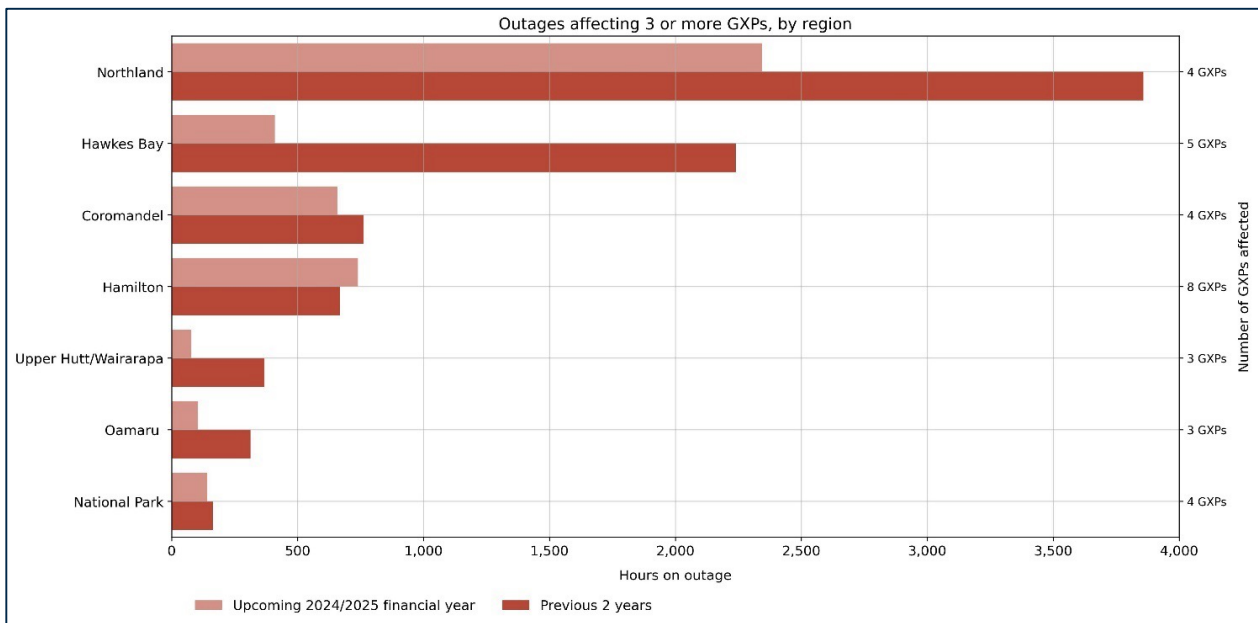
Figure 3. Hours on N security due to outages, by region of 3 or more GXPs

3.28. Table 5 shows that, amongst outages where 3 or more GXPs are affected, Northland stands out as being over-represented in the hours on N security. This is also illustrated in Figure 3 below.

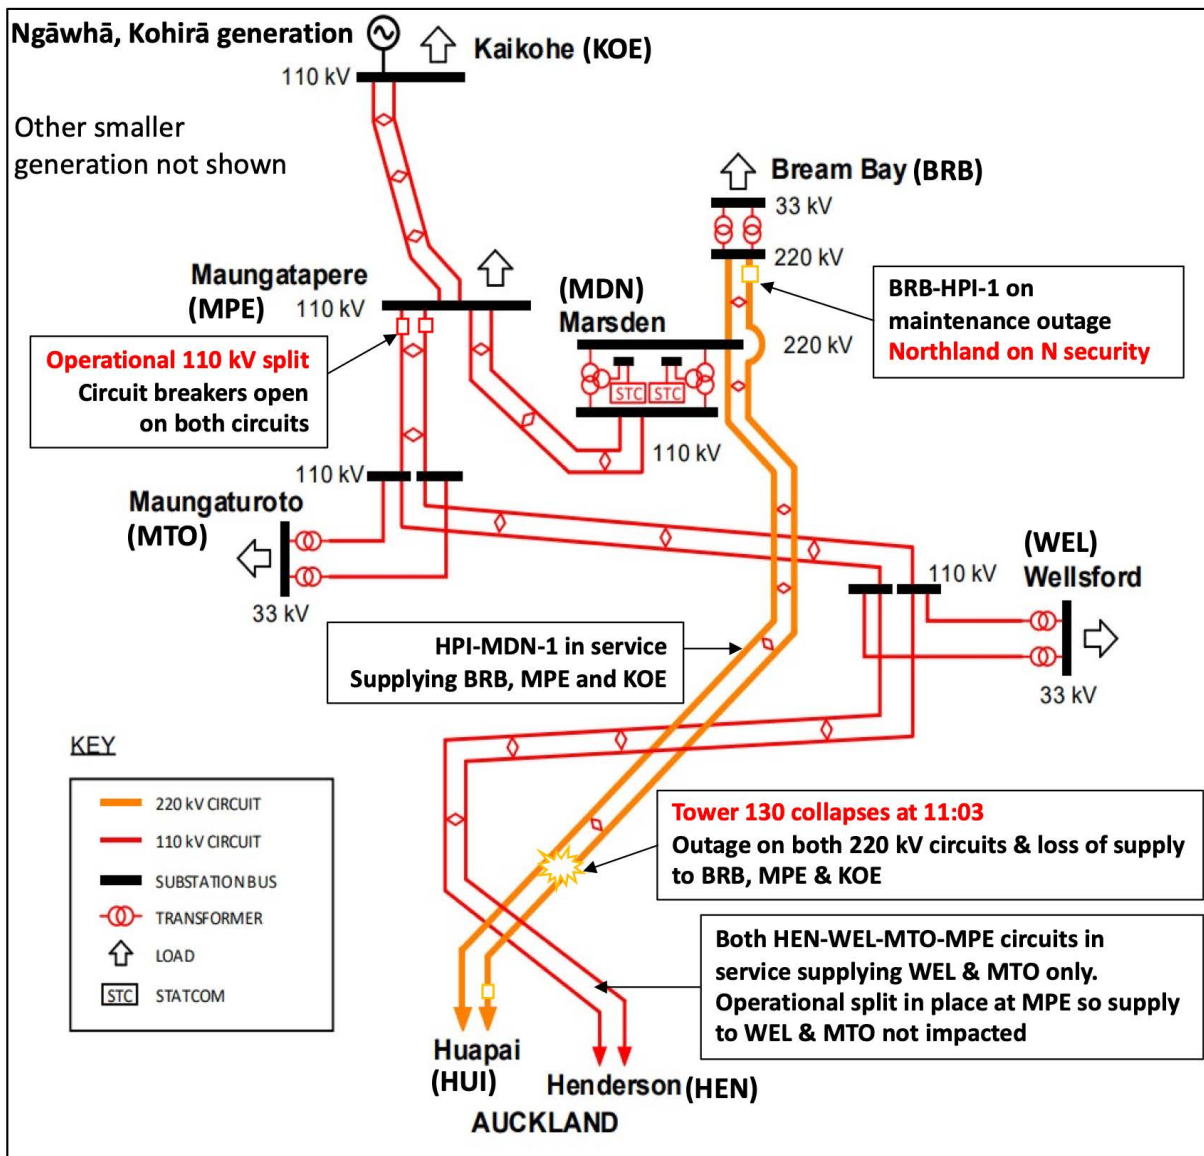
Figure 4. Northland schematic showing the key outage factors

- 7.2. Because of the way the grid was configured at the time, two Northland GXP's supplied from the Northland 110 kV network remained in service:
- (a) Maungaturoto – supplying Northpower
 - (b) Wellsford – supplying Vector.
- 7.3. Figure 4 shows the grid configuration on 20 June and the key outage factors. This includes the planned outage of one of the two 220 kV circuits into Northland – Bream Bay – Huapai circuit 1 – and the consequent 110 kV system split in place on the two 110 kV circuits via Wellsford and Maungaturoto (discussed above).

- 9.6. Figure 4 shows that the 110 kV double circuit line from Henderson to Maungatapere is the only alternative transmission line into the region. The system operator maintains a prepared step-by-step contingency plan designed for use if both 220 kV circuits become unavailable for service.⁵⁷ The contingency plan closely fitted the needs of the situation and was promptly put into action.

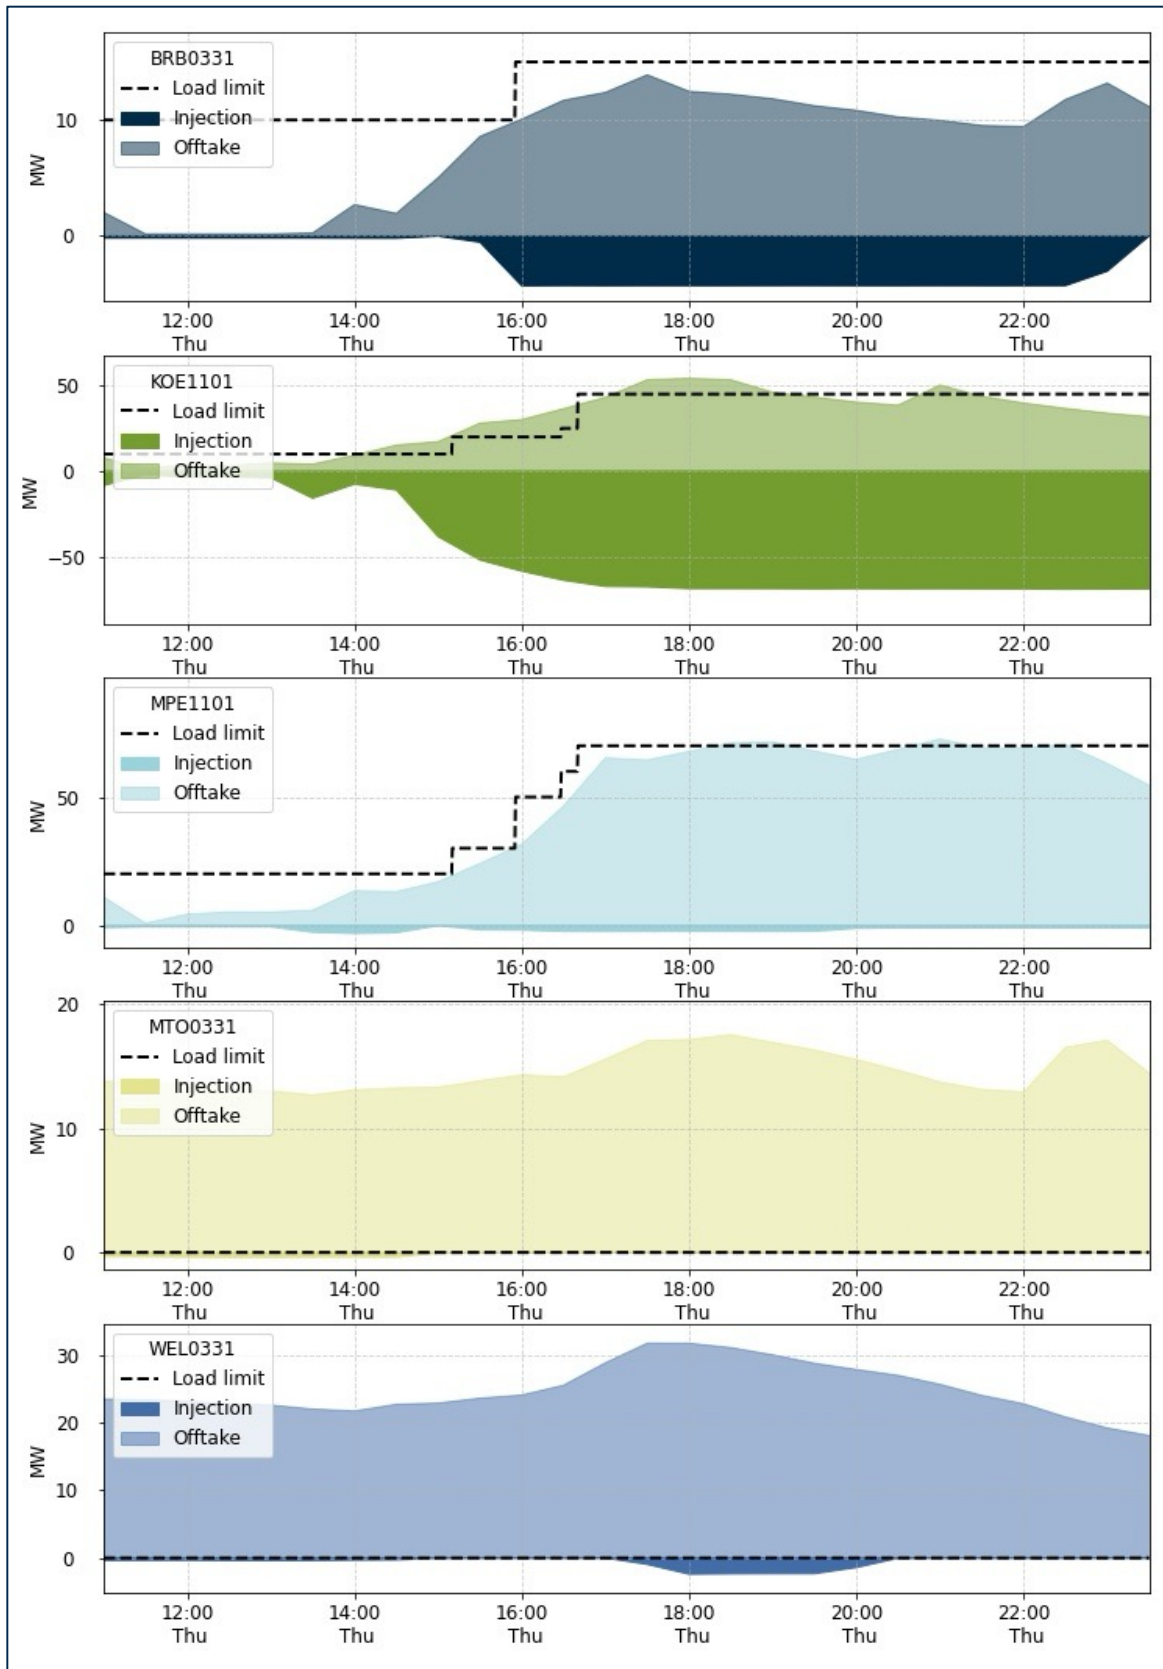
Figure 8. Load (offtake) and generation (Injection) at Northland GXP's with load limits where relevant

- 9.12. Figure 8 shows the load (offtake) and distributed generation (injection) at affected Northland GXPs along with the load limits allocated by the system operator to balance available supply with demand as the recovery progressed through the afternoon and into the evening peak. Note that the load limits apply to the net offtake at the GXP, ie, the offtake minus the injection.

- 9.15. Figure 8 shows that the distributors were able to adhere to their allocated load limits for the most part.

- 9.47. Figure 8 shows that Top Energy exceeded its load limit at Kaikohe at times. This was due to issues with its Supervisory Control and Data Acquisition (SCADA)⁶⁵ system that were identified and remedied.

- 9.53. Once generation from Ngāwhā stabilised, the grid was in a balanced state and restoration of supply and connections started. This can be seen in Figure 8 where load was progressively reconnected at the Maungatapere 110 kV bus. Northpower's ripple controllable load, in addition to Ngāwhā generation were key resources to maximise the amount of capacity available for all consumers.

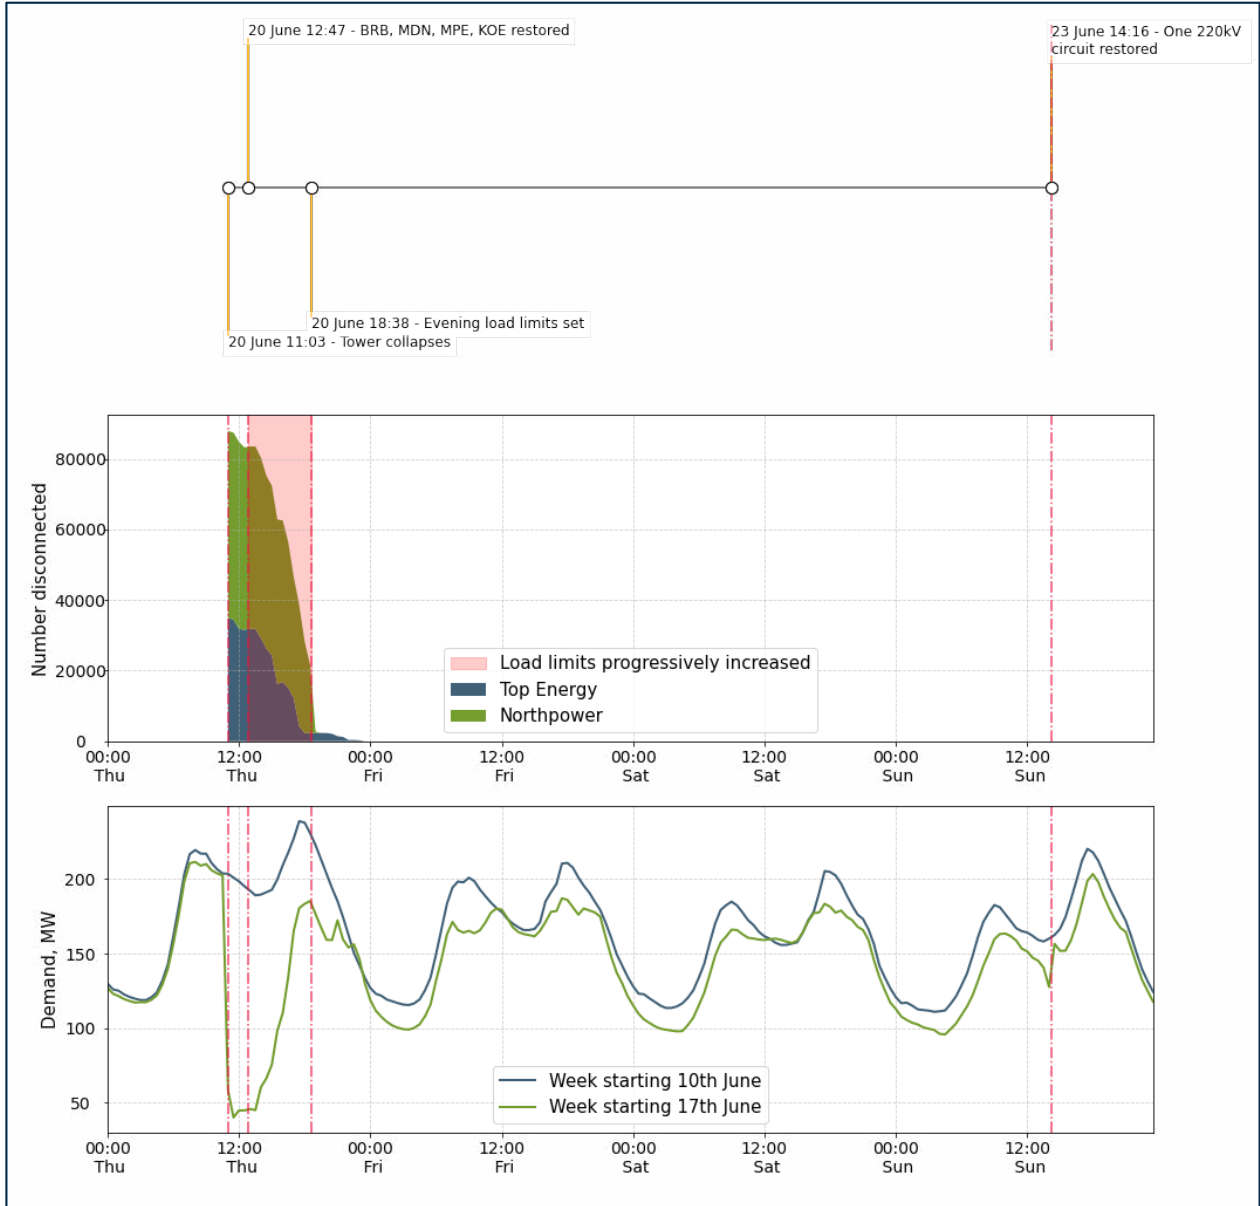
Figure 10. Event timeline, consumer disconnections and lost load

- 9.39. Figure 10 summarises the consumer impact on a timeline that shows key events in the top panel, the number of disconnected consumers in the middle panel, and compares the load that was able to be supplied during the event with the week prior in the bottom panel. The bottom panel enables us to estimate the quantity of electricity that wasn't consumed because of the outage. This estimate forms the basis for calculating the value of lost load.
- 9.40. The middle panel shows the number of disconnected consumers, starting at approximately 88,000 and dropping sharply as consumers were progressively reconnected throughout the afternoon and evening of 20 June. The middle panel also shows that a small number of consumers were able to be reconnected prior to 12.47pm when the 110 kV circuits were restored. This restoration was possible

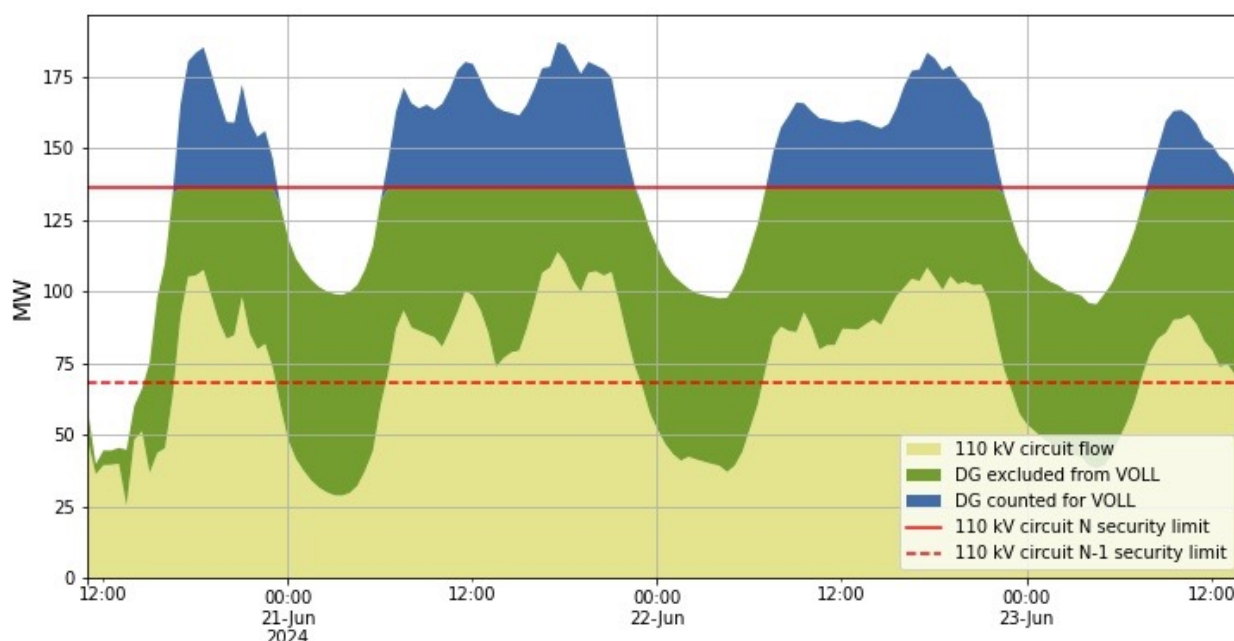
Figure 11. Distributed generation enabled more load to be supplied

- 10.11. As already noted, distributed generation in the Northland region enabled significantly more Northland load to be supplied during the event than would have been possible with the 110 kV circuits alone. Figure 11 breaks down the Northland load into three components:
