ELECTRICITY INDUSTRY PARTICIPATION CODE DISTRIBUTED UNMETERED LOAD AUDIT REPORT

WAKA KOTAHI LOWER NORTH ISLAND AND GENESIS ENERGY LIMITED

Prepared by: Rebecca Elliot

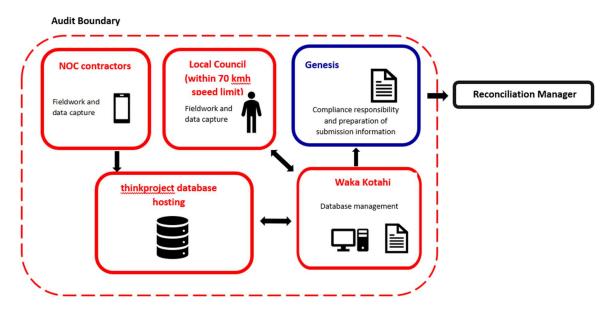
The scope of the audit encompasses the collection, security and accuracy of the data, including the preparation of submission information based on the database reporting. The diagram below shows the audit boundaries for clarity.
