ELECTRICITY INDUSTRY PARTICIPATION CODE DISTRIBUTED UNMETERED LOAD AUDIT REPORT

WAIPA DISTRICT COUNCIL AND GENESIS ENERGY NZBN:9429037706609

Prepared by: Steve Woods Date audit commenced: 29 March 2024 Date audit report completed: 27 May 2024 Audit report due date: 30-May-24

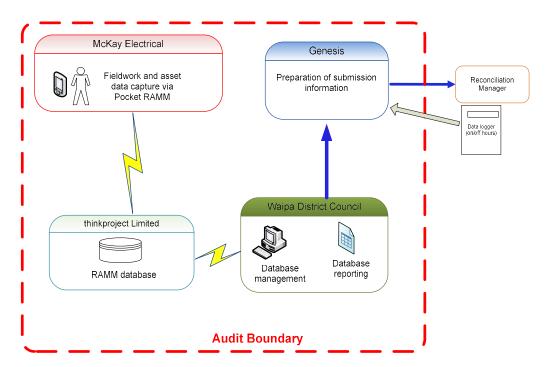
The scope of the audit encompasses the collection, security and accuracy of the data, including the preparation of submission information based on the database contents. The diagram below shows the audit boundary for clarity.

The database is remotely hosted by thinkproject New Zealand Ltd and is managed by Waipa DC. McKay Electrical conducts the installation fieldwork and maintenance. They provide information on all work carried out back to Waipa DC and this is then loaded into RAMM. Waipa DC provides reporting to Genesis on a monthly basis.
