ELECTRICITY INDUSTRY PARTICIPATION CODE  
DISTRIBUTED UNMETERED LOAD AUDIT REPORT

HASTINGS DISTRICT COUNCIL AND  
MANAWA ENERGY

Prepared by: Rebecca Elliot

Date audit commenced: 12 April 2024

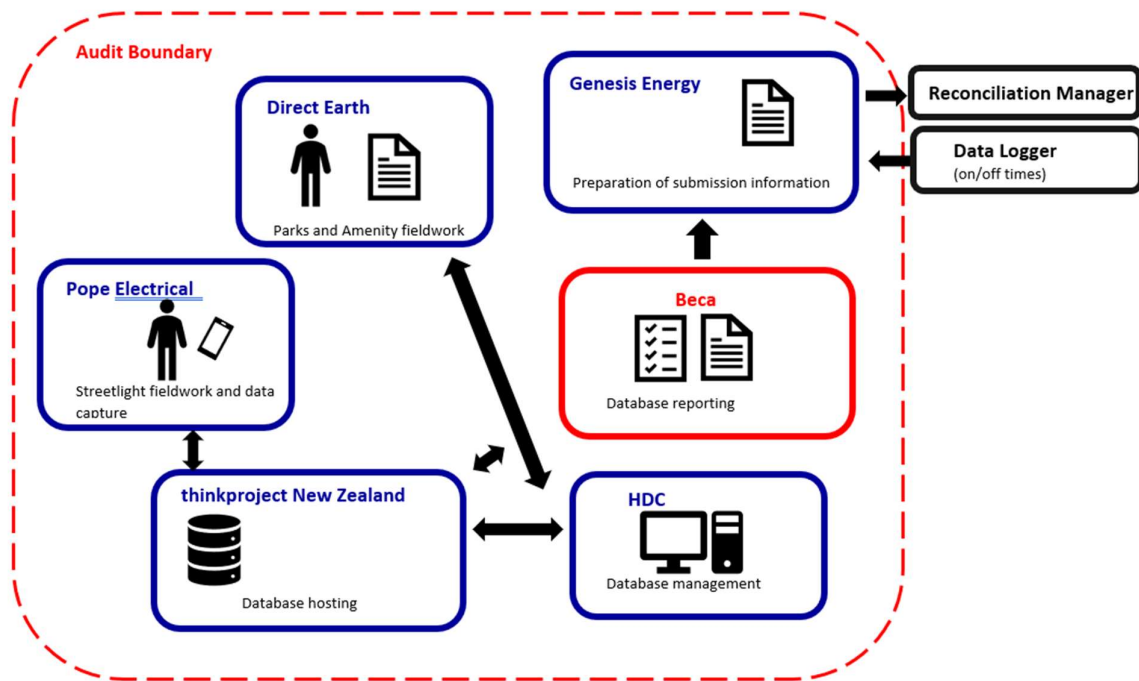
The database is remotely hosted by thinkproject New Zealand Ltd. The database population and field work are conducted by Pope Electrical for streetlights. The monthly wattage report is produced by Beca Limited on behalf of HDC. Parks and Amenity lights are also recorded in the database. Changes made in the field are expected to be advised to the Transport Department. The scope of the audit encompasses the collection, security and accuracy of the data, including the preparation of submission information based on the database reporting. The diagram below shows the audit boundary for clarity.
