ELECTRICITY INDUSTRY PARTICIPATION CODE DISTRIBUTED UNMETERED LOAD AUDIT REPORT

GISBORNE DISTRICT COUNCIL AND MERCURY ENERGY NZBN 9429037706609

Prepared by: Steve Woods

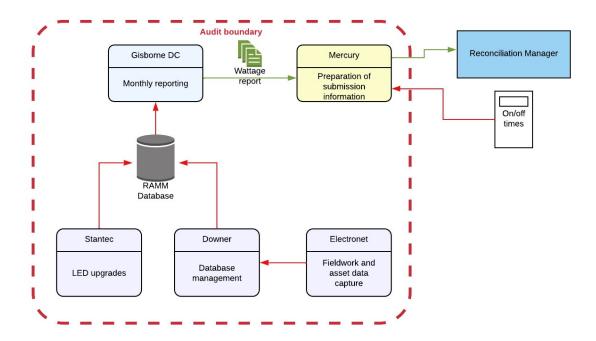
GDC provide a monthly report to Mercury. The on/off times are derived by a data logger interrogated by Bluecurrent.

The diagram below shows the audit boundary for clarity.
