ELECTRICITY INDUSTRY PARTICIPATION CODE
DISTRIBUTED UNMETERED LOAD AUDIT REPORT

KAWERAU DISTRICT COUNCIL
AND GENESIS ENERGY LIMITED
NZBN:9429037706609

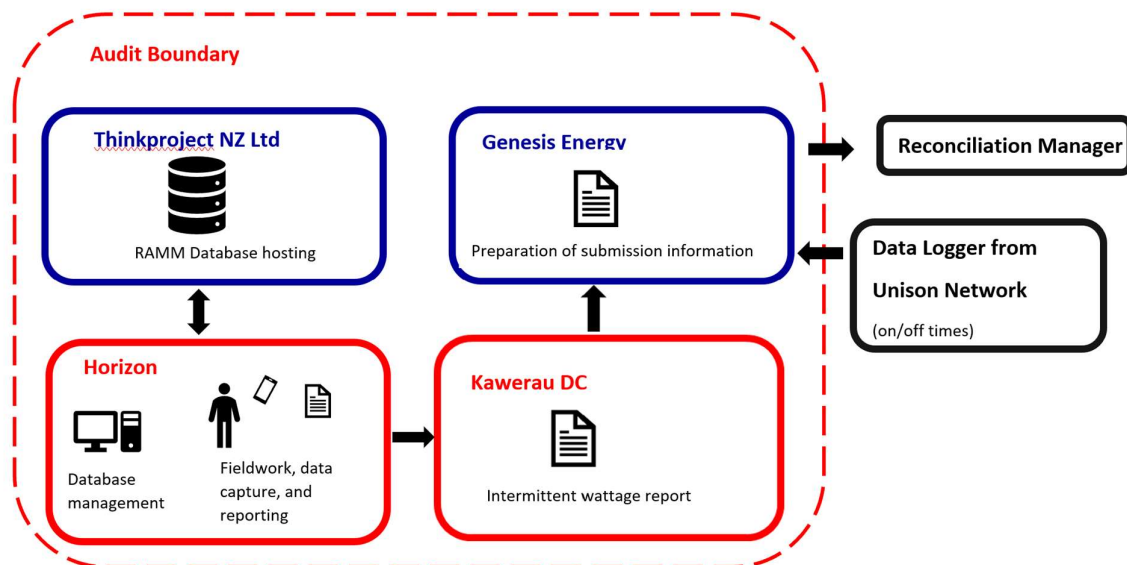
The database is remotely hosted by thinkproject Ltd. The field work is carried out by Horizon. The asset data capture and database population are conducted by Horizon. The scope of the audit encompasses the collection, security and accuracy of the data, including the preparation of submission information. The diagram below shows the audit boundary for clarity.

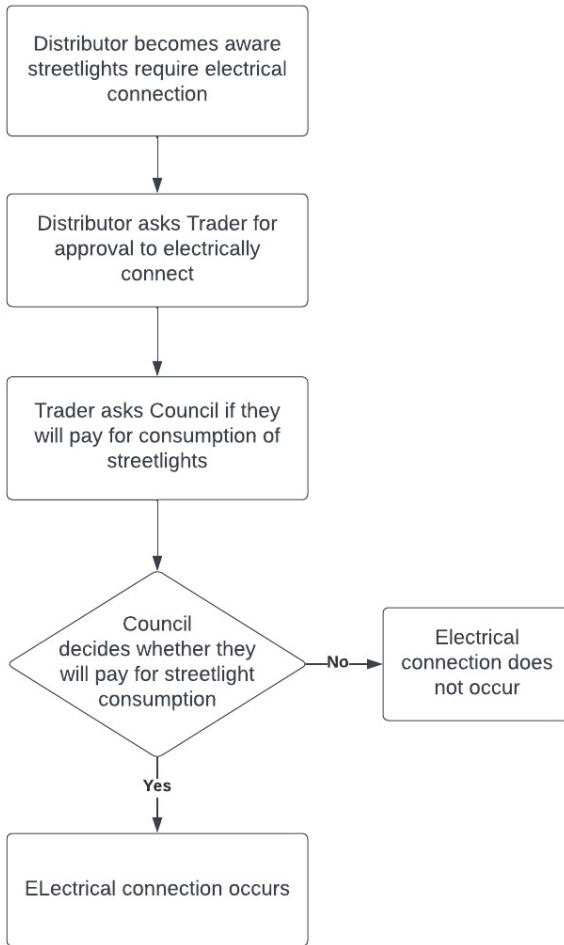
The new connections process has been reviewed and will now involve a field visit to ensure all lights are correctly recorded. I recommend the process below is adopted to ensure appropriate approvals are in place prior to electrical connection.

Description	Recommendation	Audited party comment	Remedial action
New connections	Adopt a new connections process that includes approval steps by KDC and Genesis.	<p>Kawerau DC have gone through vacancy constraints and changes in their roles, which has now all been filled however it has caused some issues in actions being taken.</p> <p>As the roles have now been billed, this will be reviewed to ensure that there is a robust new connection in place.</p> <p>Kawerau DC have been made aware of the festive lights not being provided in the data and are aware of the expectations that these need to be recorded.</p>	Identified
